Why Does My PVC Sewer Pipe Joint Have A Gap?

By Craig Fisher, P.E.
Association Engineer

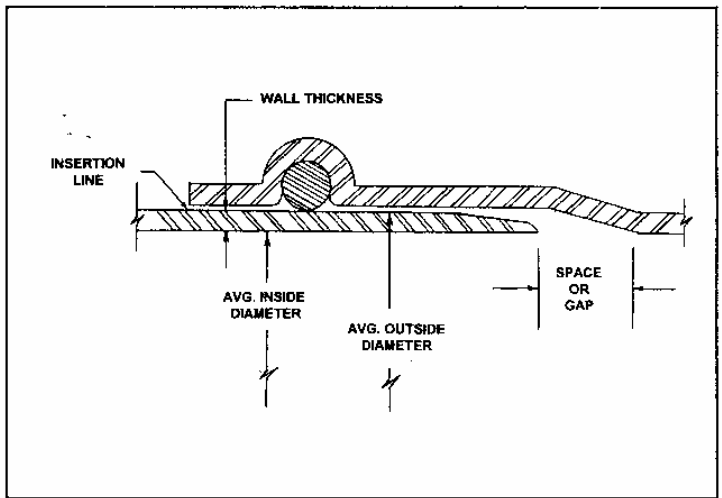
Figure 2: Illustration shows a cross-section of PVC pipe joint.

Figure 2 shows a wall cross-section of a PVC pipe joint. From Figure 2 you can see that the insertion depth allows more room for contraction than expansion. The gap opening is comparatively small.
